# model 5874PB

Fountain Valve

### INSTALLATION INSTRUCTIONS FOR 5874PBF.

### INSTALLATION INSTRUCTIONS FOR 5874PB.

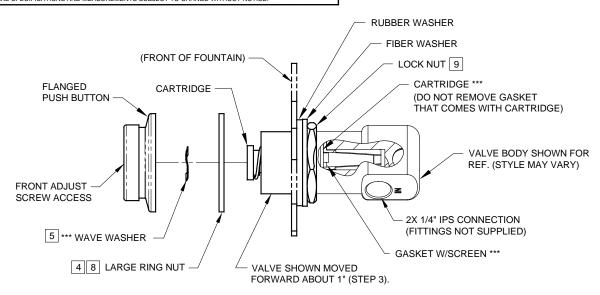
- 1) FOLLOW INSTRUCTIONS CAREFULLY ON O&M MANUAL (PAGE 2 OF 6) WHEN REMOVING OLD VALVE. NOTE: SEE PARTS BREAKDOWN (PAGE 4 OF 6) FOR ADDITIONAL NOTES.
- VERIFY THAT LOCK NUT, FIBER, AND RUBBER WASHERS ARE POSITIONED SLIGHTLY PAST MIDWAY OF THREADS ON NEW VALVE BODY.

- 3) INSERT VALVE INTO BRACKET FROM INSIDE AND PUSH FORWARD ABOUT 1".
- 4 THREAD LARGE RING NUT ONTO VALVE BODY, APPROXIMATELY 1" INTO VALVE.
- 5 PLACE WAVE WASHER INSIDE OF FLANGED PUSH BUTTON ASSEMBLY (MUST BE IN PLACE).

- 6 APPLY ONE (1) DOT OF LOCTITE 222MS, ON THE FEMALE THREADS OF BUTTON ASSEMBLY LEAVING THE FIRST AND LAST THREADS FREE. (FIGURE 1). CAUTION: EXCESS LOCTITE CAN CAUSE THREADS TO LOCK VERY TIGHTLY, MAKING REPAIRS DIFFICULT.

- \*\*7) THREAD FLANGED PUSH BUTTON ASSEMBLY ON VALVE UNTIL WAVE WASHER MAKES SLIGHT CONTACT WITH STEM OF CARTRIDGE. **CAUTION: DO NOT HAND-TIGHTEN.**
- 8 UNTHREAD RING NUT FORWARD UNTIL IT STOPS FLUSH WITH PUSH BUTTON ASSEMBLY.

- 9 PUSH VALVE BACK TOWARD THE INSIDE OF BRACKET AND TIGHTEN LOCKNUT (SEE ILLUSTRATION ABOVE).
- 10) TIGHTEN PUSH BUTTON ASSEMBLY USING UNIVERSAL SPANNER WRENCH PROVIDED.

- \*\* OVERTIGHTENING WILL PRE-ACTUATE VALVE AND CAUSE WEEPAGE, WHILE NOT ENOUGH CONTACT BETWEEN WAVE WASHER AND STEM CAN CAUSE A LOW FLOW CONDITION.

ASSEMBLED 5874PBF (FLUSH MOUNT APPLICATION)

With its patented push-button design which allows for front access stream adjustment as well as cartridge and strainer access, this valve offers the ultimate in ease of maintenance.

The push-button activated valve offers the only all stainless steel valve body that is machined out of solid bar stock, is fully serviceable through the front of the push button assembly offering access to the water control cartridge and integral water supply strainer, and with front access to the water stream height adjustment for easy maintenance without having to remove the valve. Operating pressure range of 30 to 90 psi (2.1 to 6.2 bar).

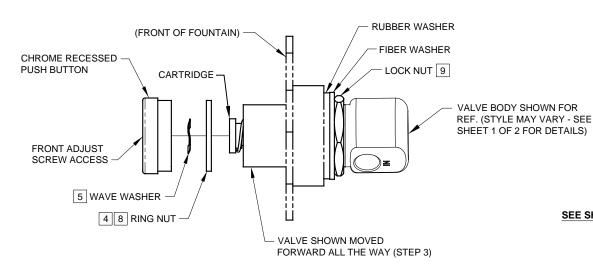
ASSEMBLED 5874PB (RECESSED MOUNT APPLICATION)

- 1) FOLLOW INSTRUCTIONS CAREFULLY ON O&M MANUAL (PAGE 2 OF 6) WHEN REMOVING OLD VALVE. NOTE: SEE PARTS BREAKDOWN (PAGE 4 OF 6) FOR ADDITIONAL NOTES.
- 2) VERIFY THAT LOCK NUT, FIBER WASHER, AND RUBBER WASHERS ARE POSITIONED TOWARD BOTTOM END OF THREADS ON NEW VALVE BODY.
- 3) INSERT VALVE INTO BRACKET FROM INSIDE, AND PUSH ALL THE WAY FORWARD (SEE ILLUSTRATION ABOVE).
- 4 THREAD RING NUT ONTO VALVE BODY, AS FAR IN AS POSSIBLE, TOWARD FRONT OF FOUNTAIN.

NOTE: IF REPLACING A 5871 OR 5872 SERIES VALVE. YOU MAY HAVE TO CONTACT HAWS TECHNICAL SUPPORT.
- 5 PLACE WAVE WASHER INSIDE OF PUSH BUTTON ASSEMBLY (MUST BE IN PLACE).

- 6 APPLY ONE (1) DOT OF LOCTITE 222MS, ON THE FEMALE THREADS OF BUTTON ASSEMBLY LEAVING THE FIRST AND LAST THREADS FREE. (FIGURE 1). CAUTION: EXCESS LOCTITE CAN CAUSE THREADS TO LOCK VERY TIGHTLY, MAKING REPAIRS DIFFICULT.

- \*\*7) THREAD PUSH BUTTON ASSEMBLY ON VALVE UNTIL WAVE WASHER MAKES SLIGHT CONTACT WITH STEM OF CARTRIDGE. CAUTION: DO NOT HAND-TIGHTEN.
- 8 UNTHREAD RING NUT FORWARD UNTIL IT STOPS FLUSH WITH PUSH BUTTON ASSEMBLY.

- 9 PUSH VALVE BACK TOWARD THE INSIDE OF BRACKET AND TIGHTEN LOCKNUT (SEE ILLUSTRATION ABOVE).
- 10) TIGHTEN PUSH BUTTON ASSEMBLY USING UNIVERSAL SPANNER WRENCH PROVIDED.

- \*\* OVERTIGHTENING WILL PRE-ACTUATE VALVE AND CAUSE WEEPAGE, WHILE NOT ENOUGH CONTACT BETWEEN WAVE WASHER AND STEM CAN CAUSE A LOW FLOW CONDITION.
