# model 5874SS Faucets and Valves

Model 5874SS fountain valve is a stainless steel push button valve with front stream adjustment and cartridge servicing. It uses automatic pressure regulation from 30 - 90 psi (2.1 - 6.2 bar) and has a 1/4" IPS inlet and outlet.

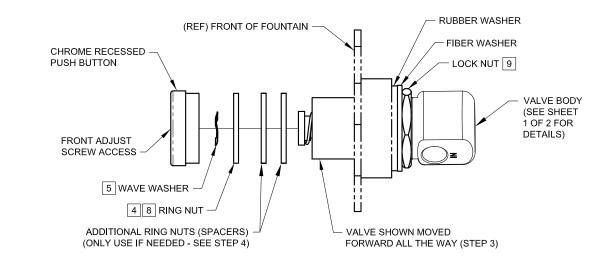
ASSEMBLED 5874PB (RECESSED MOUNT APPLICATION)

- 2) VERIFY THAT LOCK NUT, FIBER, AND RUBBER WASHERS ARE POSITIONED TOWARD BOTTOM END OF THREADS ON NEW VALVE BODY.
- 3) INSERT VALVE INTO FOUNTAIN FROM INSIDE, AND PUSH ALL THE WAY FORWARD (SEE ILLUSTRATION ABOVE).

- 4 THREAD RING NUT ONTO VALVE BODY, AS FAR IN AS POSSIBLE, TOWARD FRONT OF FOUNTAIN. NOTE: IF REPLACING A 5871 OR 5872 SERIES VALVE, YOU MAY HAVE TO PLACE ADDITIONAL RING NUTS ( TO BE USED AS SPACERS AND SUPPLIED W/5874PB) IN FRONT OF THE RING NUT (SEE ILLUSTRATION ABOVE), TO ALLOW NEW LONGER VALVE TO FIT IN A TIGHT LOCATION.

- 9 PUSH VALVE BACK TOWARD THE INSIDE OF FOUNTAIN AND TIGHTEN LOCKNUT (SEE ILLUSTRATION ABOVE).
- 10) TIGHTEN PUSH BUTTON ASSEMBLY USING UNIVERSAL SPANNER WRENCH PROVIDED.
