## FEATURES & BENEFITS

## SPECIFICATIONS

## INSTALLATION INSTRUCTIONS FOR 5874PBF.

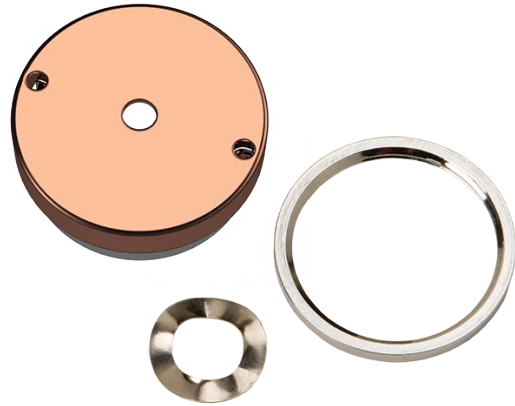
Model PBA7C flanged push button assembly is used with push button valve 5874. The button is made with 99.9% copper plating, and the flange and nut made of polished chrome-plated brass. The push button includes access to the front adjusting screw. This button assembly is used on most recessed mounted (not flush to surface) push button drinking fountain models.

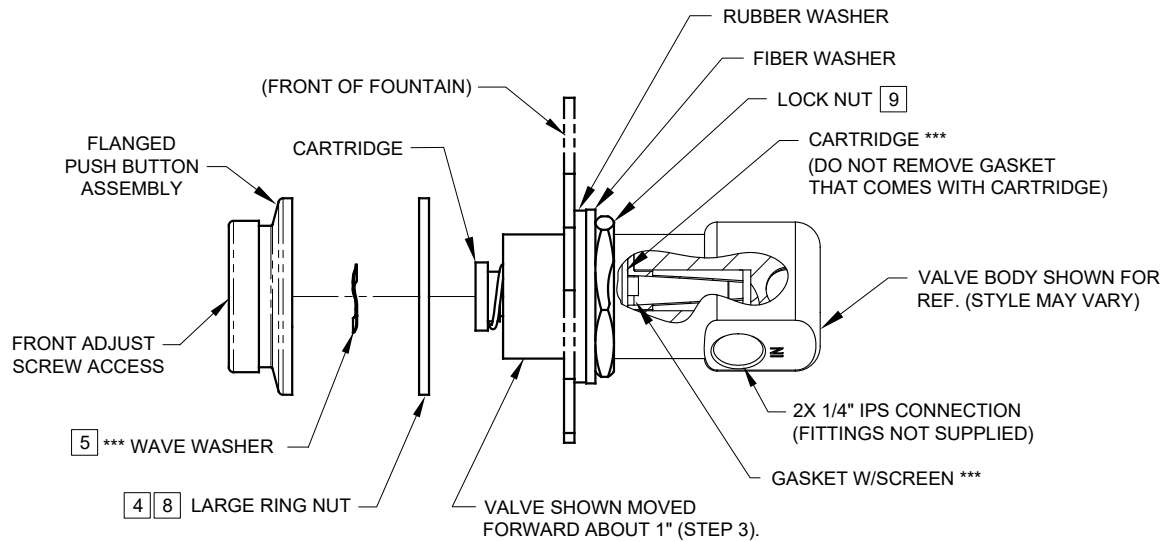
ASSEMBLED 5874PBF  
(FLUSH MOUNT APPLICATION ONLY)

\*\*\* MODEL VRK5874 & VRK5874HF- VALVE REPAIR KITS INCLUDE THESE ITEMS

- 1) FOLLOW INSTRUCTIONS CAREFULLY ON O&M MANUAL (PAGE 2 OF 6) WHEN REMOVING OLD VALVE. **NOTE: SEE PARTS BREAKDOWN (PAGE 4 OF 6) FOR ADDITIONAL NOTES.**

- 2) VERIFY THAT LOCK NUT, FIBER, AND RUBBER WASHERS ARE POSITIONED SLIGHTLY PAST MIDWAY OF THREADS ON NEW VALVE BODY.
- 3) INSERT VALVE INTO BRACKET FROM INSIDE AND PUSH FORWARD ABOUT 1".

- [4] THREAD LARGE RING NUT ONTO VALVE BODY, APPROXIMATELY 1" INTO VALVE.
- [5] PLACE WAVE WASHER INSIDE OF FLANGED PUSH BUTTON ASSEMBLY (**MUST BE IN PLACE**).

- [6] APPLY ONE (1) DOT OF LOCTITE 222MS, ON THE FEMALE THREADS OF BUTTON ASSEMBLY LEAVING THE FIRST AND LAST THREADS FREE. (FIGURE 1). **CAUTION: EXCESS LOCTITE CAN CAUSE THREADS TO LOCK VERY TIGHTLY, MAKING REPAIRS DIFFICULT.**

- \*\*7) THREAD FLANGED PUSH BUTTON ASSEMBLY ON VALVE UNTIL WAVE WASHER MAKES SLIGHT CONTACT WITH STEM OF CARTRIDGE. **CAUTION: DO NOT HAND-TIGHTEN.**
- [8] UNTHREAD RING NUT FORWARD UNTIL IT STOPS FLUSH WITH PUSH BUTTON ASSEMBLY.

- [9] PUSH VALVE BACK TOWARD THE INSIDE OF BRACKET AND TIGHTEN LOCKNUT (SEE ILLUSTRATION ABOVE).
- 10) TIGHTEN PUSH BUTTON ASSEMBLY USING UNIVERSAL SPANNER WRENCH PROVIDED.

\*\* OVERTIGHTENING WILL PRE-ACTUATE VALVE AND CAUSE WEEPAGE, WHILE NOT ENOUGH CONTACT BETWEEN WAVE WASHER AND STEM CAN CAUSE A LOW FLOW CONDITION.

\* [6] APPLY 1 DOT OF LOCTITE 222MS (WHERE SHOWN)

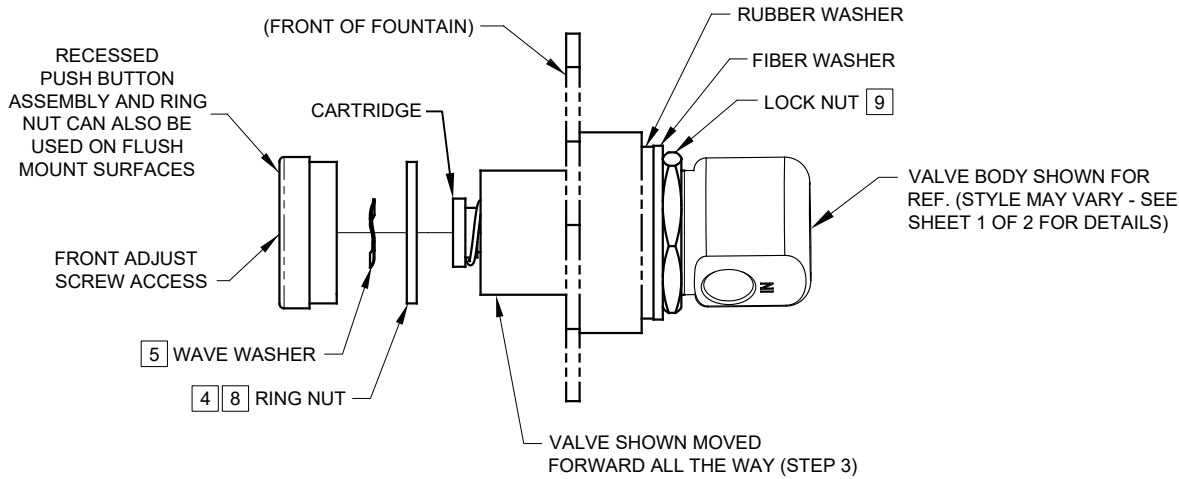
ASSEMBLED 5874PB  
(RECESSED MOUNT APPLICATION SHOWN)

**SEE SHEET 1 OF 2 FOR FLUSH MOUNT INSTRUCTIONS.**

- 5) PLACE WAVE WASHER INSIDE OF PUSH BUTTON ASSEMBLY (**MUST BE IN PLACE**).
  - 6) APPLY ONE (1) DOT OF LOCTITE 222MS, ON THE FEMALE THREADS OF BUTTON ASSEMBLY LEAVING THE FIRST AND LAST THREADS FREE. (FIGURE 1). **CAUTION: EXCESS LOCTITE CAN CAUSE THREADS TO LOCK VERY TIGHTLY, MAKING REPAIRS DIFFICULT.**

- \*\* OVERTIGHTENING WILL PRE-ACTUATE VALVE AND CAUSE WEEPAGE, WHILE NOT ENOUGH CONTACT BETWEEN WAVE WASHER AND STEM CAN CAUSE A LOW FLOW CONDITION.
